Missouri Registry Annual Report

Registry of Confirmed Abandoned or Uncontrolled Hazardous Waste Disposal Sites in Missouri

Fiscal Year 2010

Missouri Department of Natural Resources
Division of Environmental Quality
Hazardous Waste Program

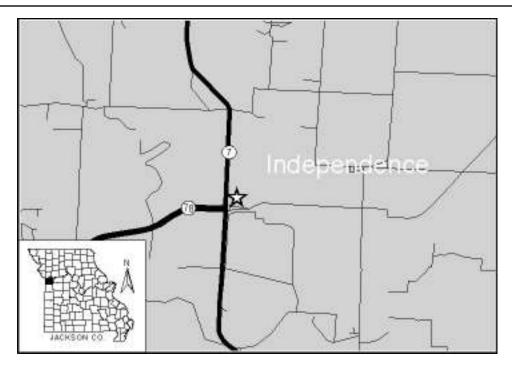
A fence has been erected around the property. Within the last six months, soil excavated from the old solvent tank farm is piled up awaiting removal.

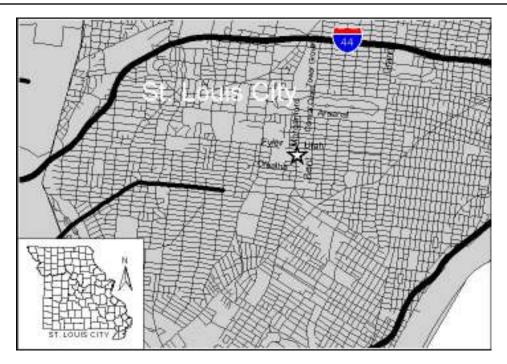
The site is fenced and secured to prevent public access, and the contaminated soil is covered by asphalt. Contaminants could

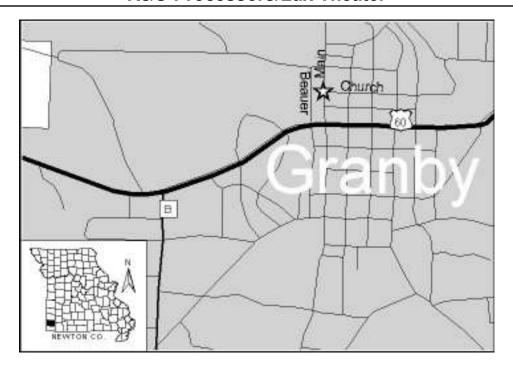
Until the remediation is complete, the site represents a potential health threat. According to DNR's 2009 annual registry site inspection, the site has been backfilled and has a gravel surface on which the asphalt cap will be installed. The last site report shows 9737 tons of soil has been excavated and sent to Veolia Subtitle D landfill in Macon. MO: 6000 tons of "source" materials (i.e. coal tars and/or heavily impacted soils) were sent to Peoria Disposal Company #1 Subtitle C landfill in Peoria, IL; and 1852 tons of source materials were sent to the Heritage Subtitle C landfill in Indiana. 158000 gallons of water was treated and discharged to the Moberly. MO sewage treatment plant.

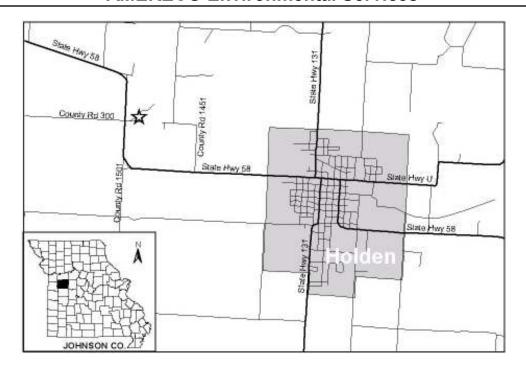
Year after year, Missouri Department of Natural Resources continues to identify leachate outbreak on the south slope of the landfill. Although the leachate has not discharged offsite, the potential does exist, particularly during wet weather. DNR has suggested to the owner that the area should be dug out, recompacted with clay, and reseeded. The owner needs to address this problem to prevent on-site exposures to toxic wastes.

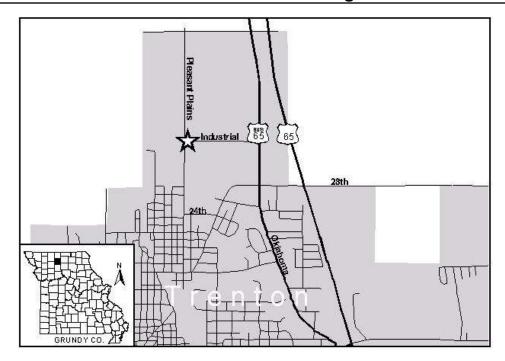
According to DNR's 2007 site inspection report, houses on site previously reported as having deteriorated as to be a health hazard have been torn down and hauled away except for one house at the west end of the property
